# Annual Waterways Report

## Clyde Catchment

Water Assessment Branch

2009

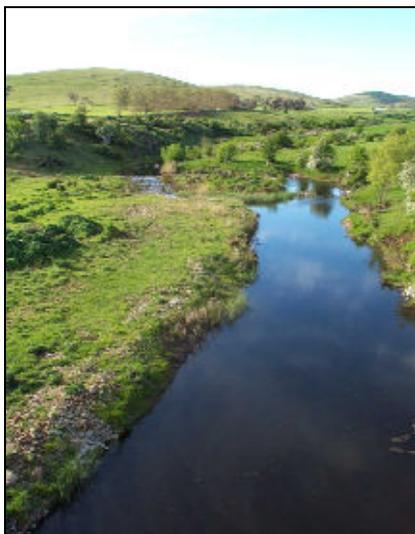
**Fig:** Clyde River below Hamilton.

This site is located downstream of the town of Hamilton and approximately 4 kilometres above the confluence of the Clyde and Derwent rivers. The surrounding land is used primarily for agricultural activities. Most of the riparian vegetation on both sides of the river has been cleared for grazing and the small amount remaining is dominated by non-native species such as willows, blackberries and hawthorn.

Within the stream habitat consists of deep pools and slow flowing runs over pebble / gravel substrate. Stock access and effluent discharge from Hamilton's sewerage treatment plant appear to have impacted on water quality and the condition of the instream habitat. A fine layer of silt and filamentous algae covers more than 70% of the substrate.
