JORDAN RIVER

FLOOD DATA BOOK

Jordan River Flood Data Book

Report Series WRA 00/02
May 2000.

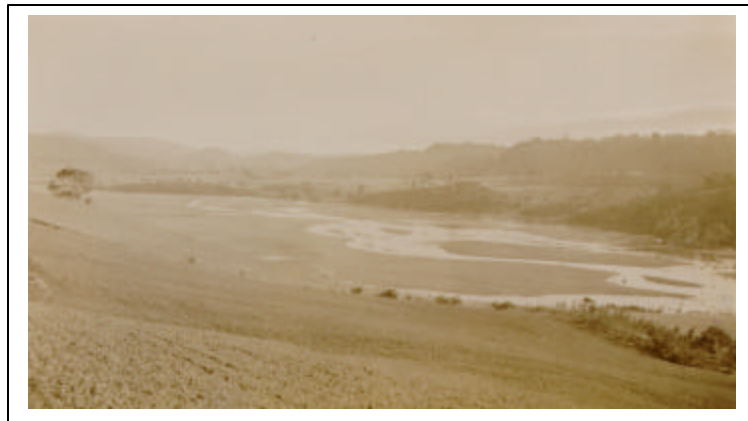
Plate 1: Early 1930 – This photograph highlights the Jordan River in flood near the *Parki* property.

Flooding is first detailed in the photographic record in 1930 when floodwaters at the *Parki* property and along the Jordan River was recorded. Flooding is next recorded in July 1974 at *Apsley Park*. During August 1975, flooding was photographed at the *Tarella* property near Mauriceton. At this time, floodwater inundated the two fords located on the property and rose to the pump house floor.

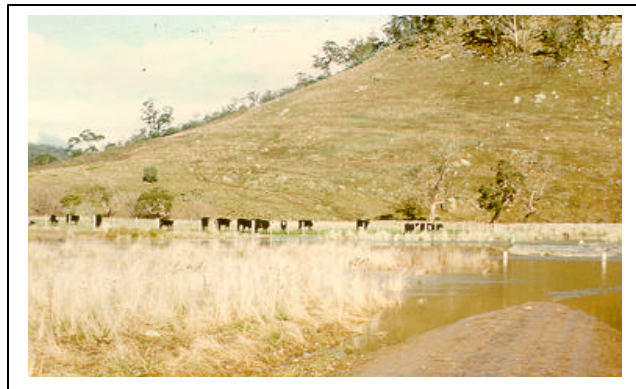
Plate 2: August 1975 – Flooding at the *Tarella* property and here, the two fords in flood are pictured (the posts mark the upstream position of the two fords).

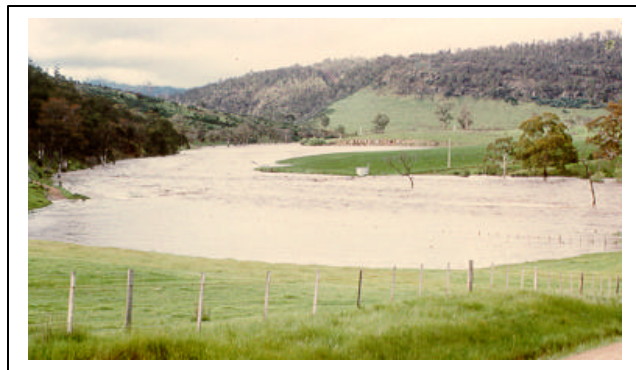
Plate 3: November 1975 – Flooding at the *Tarella* property and here, the Clifton Vale Bridge is submerged and floodwaters reached the pump house floor.

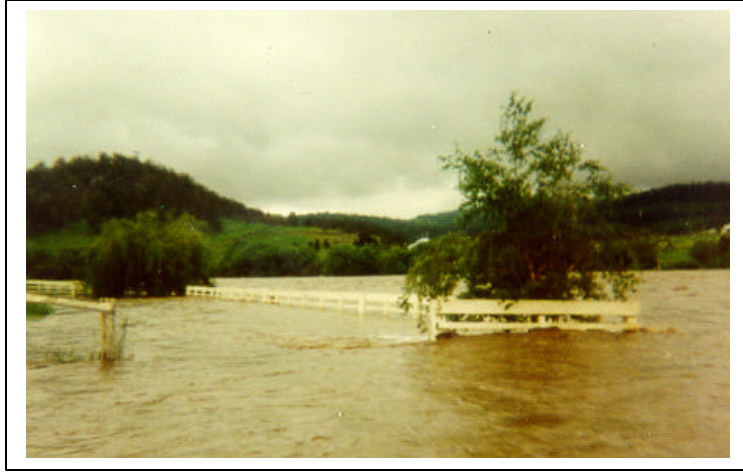
Plate 4: November 1975 – Flooding at the front fence of the *Valleyfield* property.

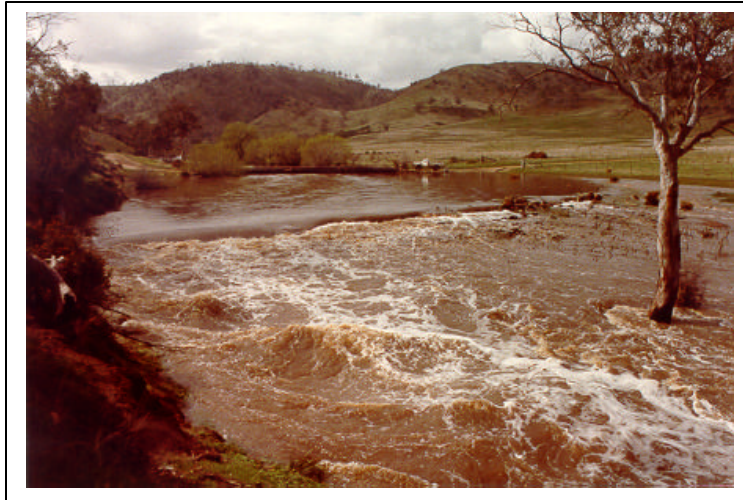
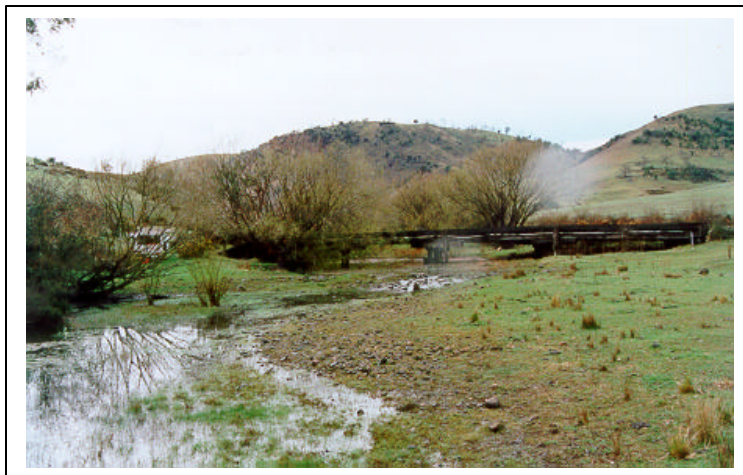
Plates 5 and 6: High and low flows in the Jordan River at Mauriceton. Floodwater in September 1984 is detailed above. Below is the flow in September 1998. Here, the river level could be considered *relatively normal* for the spring period.
